2008 ANNUAL REPORT

CANYON FUEL COMPANY, LLC SUFCO MINE ACT/041/002

Re: 2008 Annual Report for Canyon Fuel Company LLC, SUFCO Mine
C/041/002, Sevier County, Utah

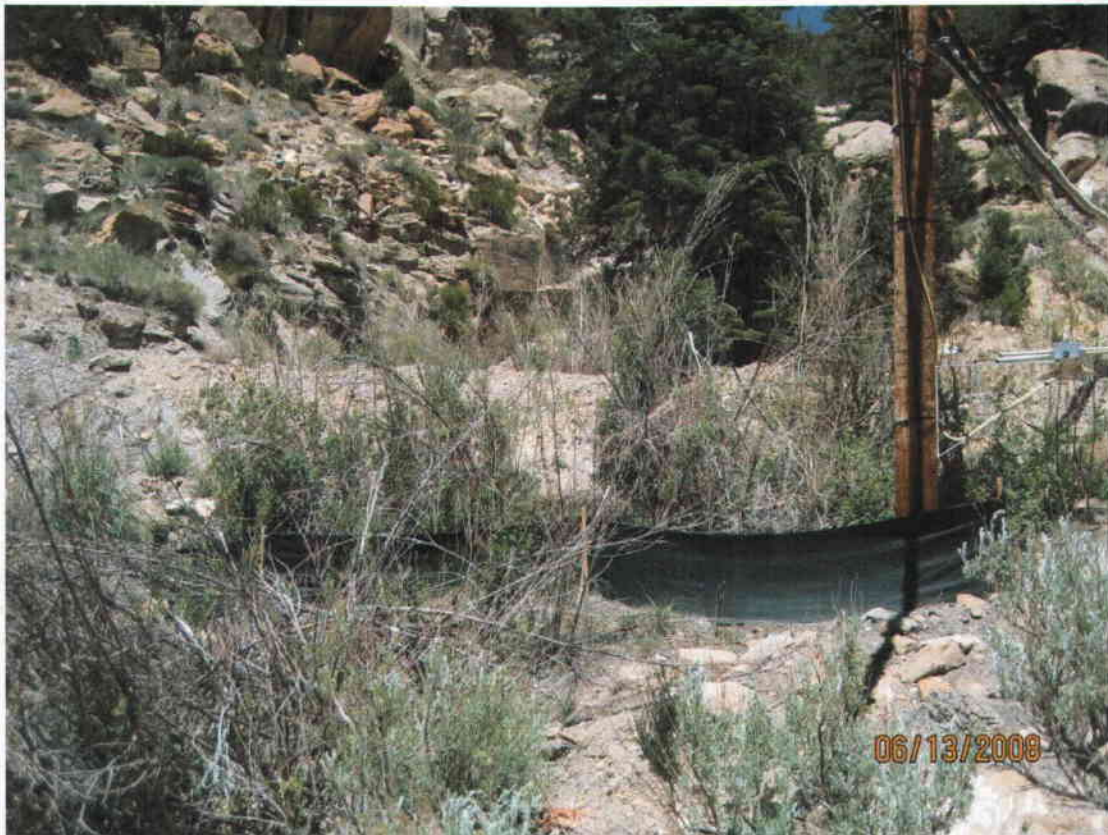
Link Canyon West Portal Photo Point

There is no water discharge from this portal and there is no evidence that there has been any. The Willow (*Salix spp.*) has suffered a severe die back. Approximate 60 % of aerial stems have died. It is difficult to determine if this die back is due to lack of moisture or

winter kill. On the living aerial stems the new growth is 6-10 inches and have not yet begin to flower. There is some basal sprouting on some of the plants where the aerial stems are dead. There are no insect galls on the willows at this time. Woods Rose (*Rosa woodsii*) has no blooms or indications that it will bloom. The current new growth on the Rose plants is 2-3 inches. Bluegrass (*Poa pratensis*) density is very low. The bluegrass has 6-8 inches of new growth, but no seed heads. The density of wiregrass (*Juncus balticus*) continues to be low. The wiregrass plants are just coming into bloom and have 8-10 inches of new growth. The Clematis (*Clematis ligusticifolia*) is just starting to leaf out and is starting this years growth. The Squawbush (*Rhus aromatica* var *trilobata*) has bloomed and has set some seed. The new growth is 2-3 inches in length. The overall growth and vigor of this site continues in a downward trend.

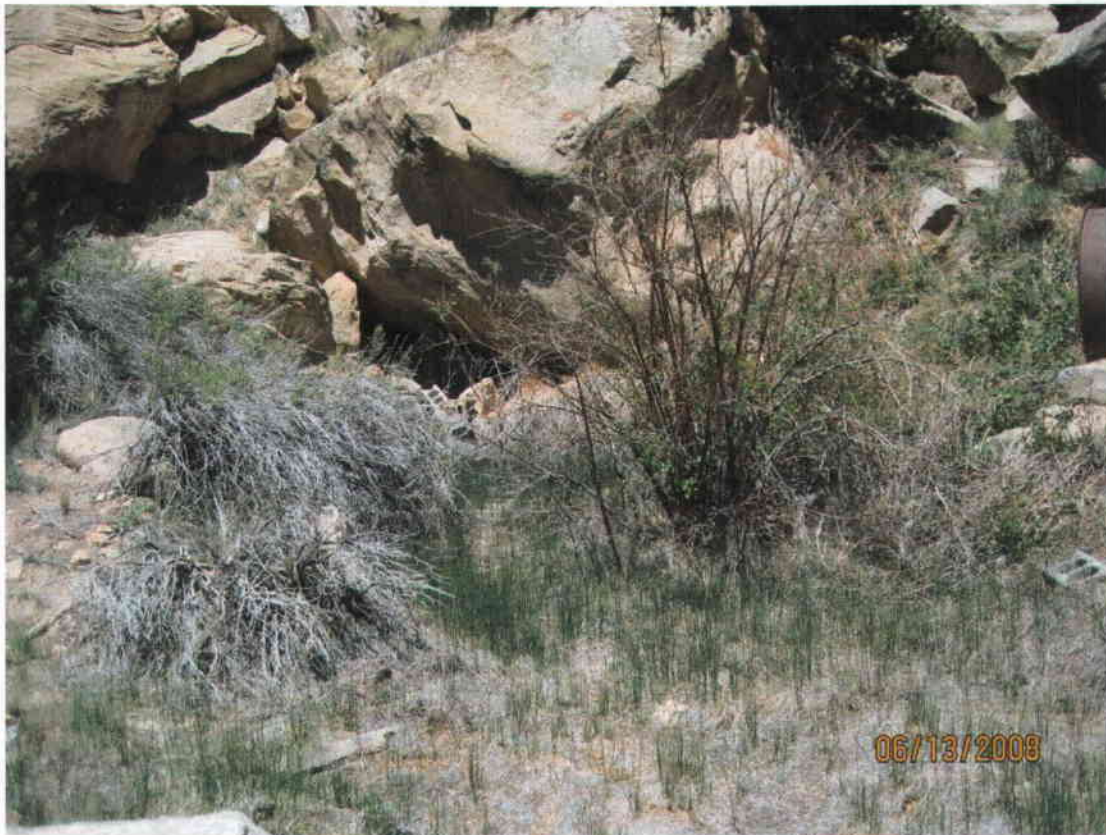
Link Canyon East Portal Photo Point

There is no water discharging from this portal and there is no evidence that there has been any. The density of wiregrass is approximately 40% and some of the plants are just coming into bloom. The current growth is 10-12 inches in length. Bluegrass plant

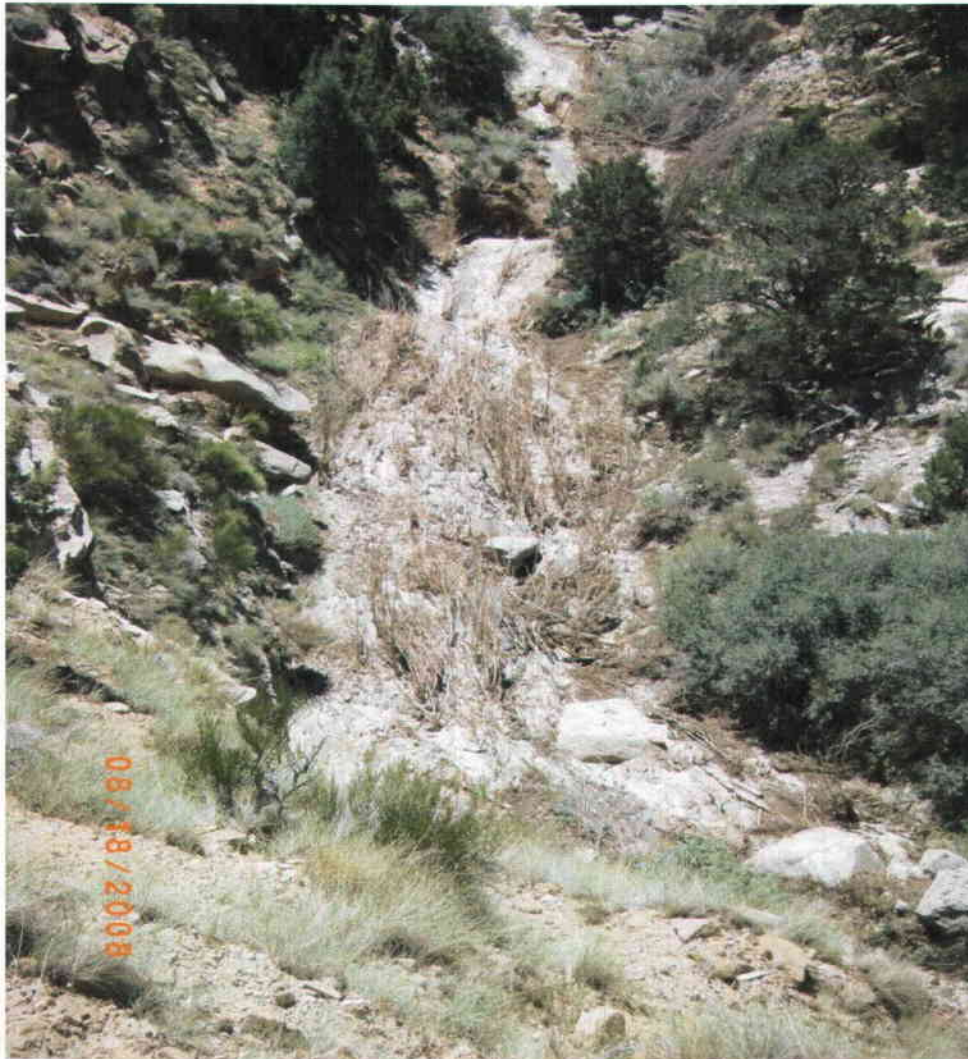
The Link Canon Mine Portal area was subjected to flash flood event in mid-August 2008. Although the exact flow volume of the flash flood is not known it is event that the flood waters were at least 47 inches deep. This is known by the flood debris that was deposited on vegetation adjacent to the flood path. The vegetative study area at the West Portal was almost completely destroyed by this flood event as shown in Photo 1.

Photo 1- Flood damage at West Portal

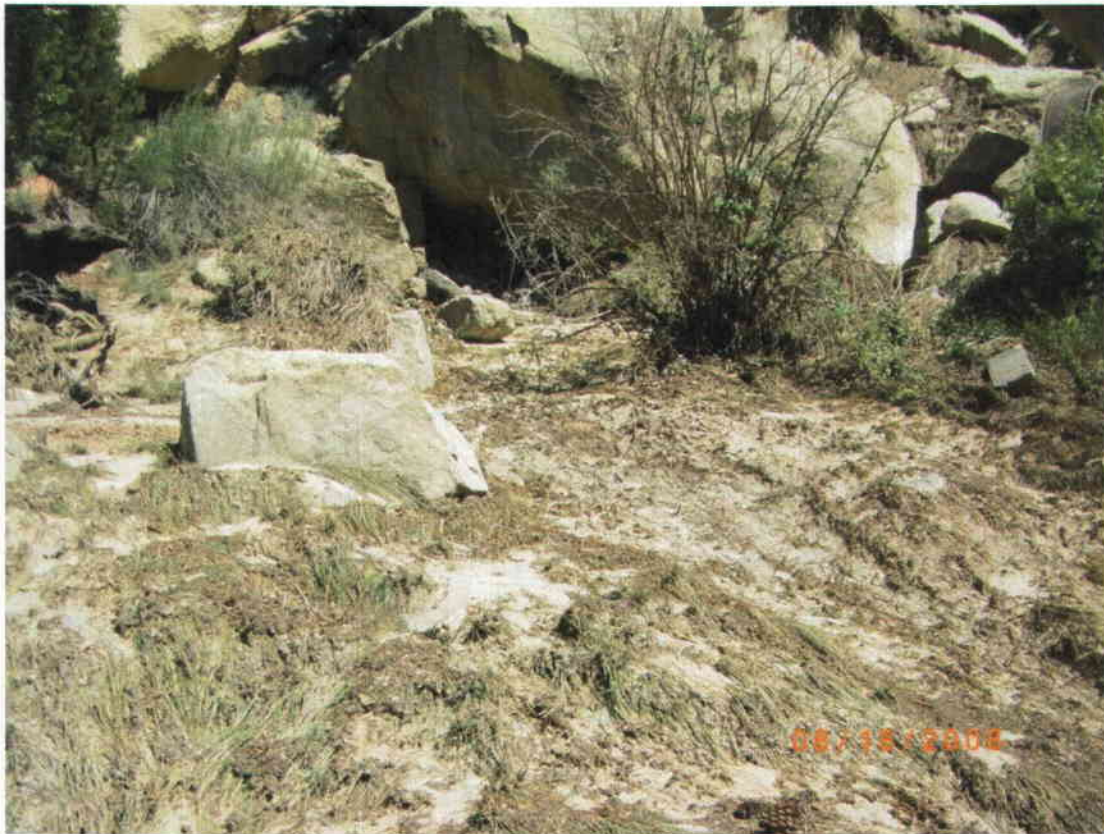
Photo 2-East Portal Area

The damage at the East Portal was not as severe. Although there was considerable damage to the site some of the riparian vegetation remained, (primarily *Juncus spp.*) Photo 2 shows the flood damage at the East Portal.

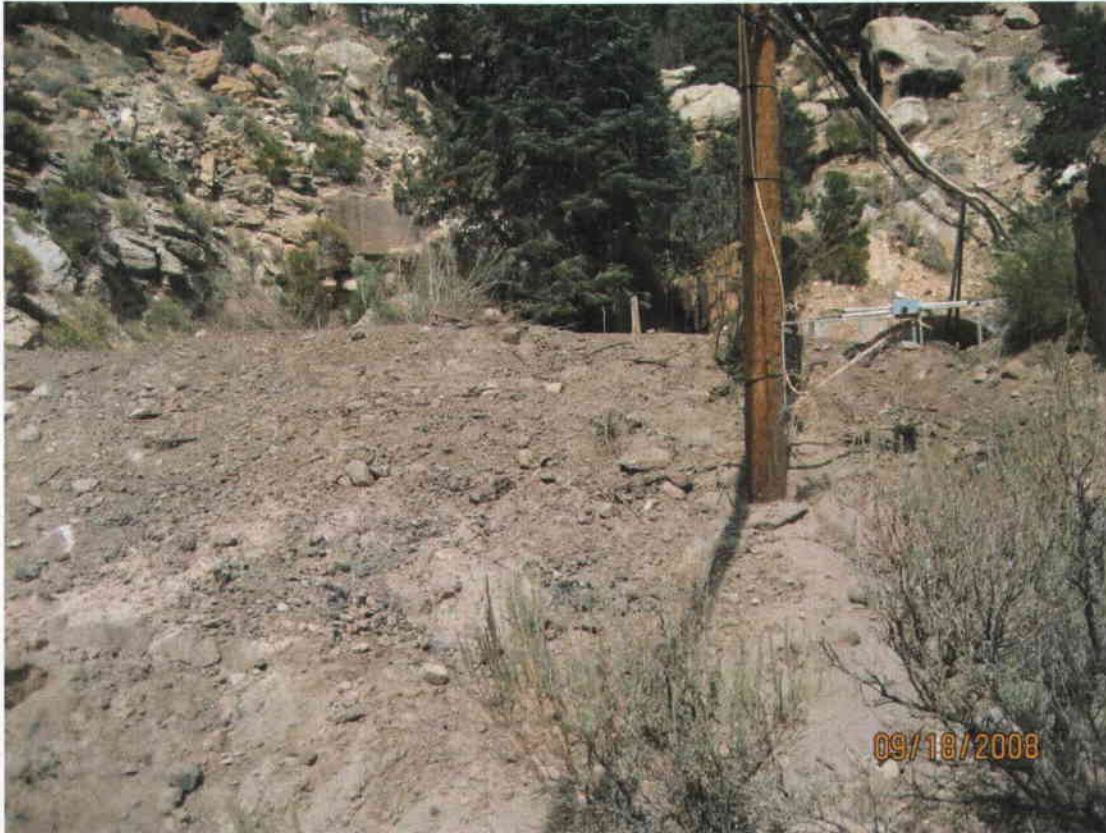
Link Canyon West Portal Photo Point

The riparian vegetation at this site was almost completely destroyed except for one branch of the Squawbush (*Rhus aramatica* var. *trilobata*) and one small willow (*Salix* spp.) plant. The site has been reclaimed by the SUFCO Mine and has been seeded with the approved interim seed mix. It is possible that there could be some root sprouts from any remaining willow roots. However, the probability is quite small. Only time will tell. There is no water being discharged from this Portal.

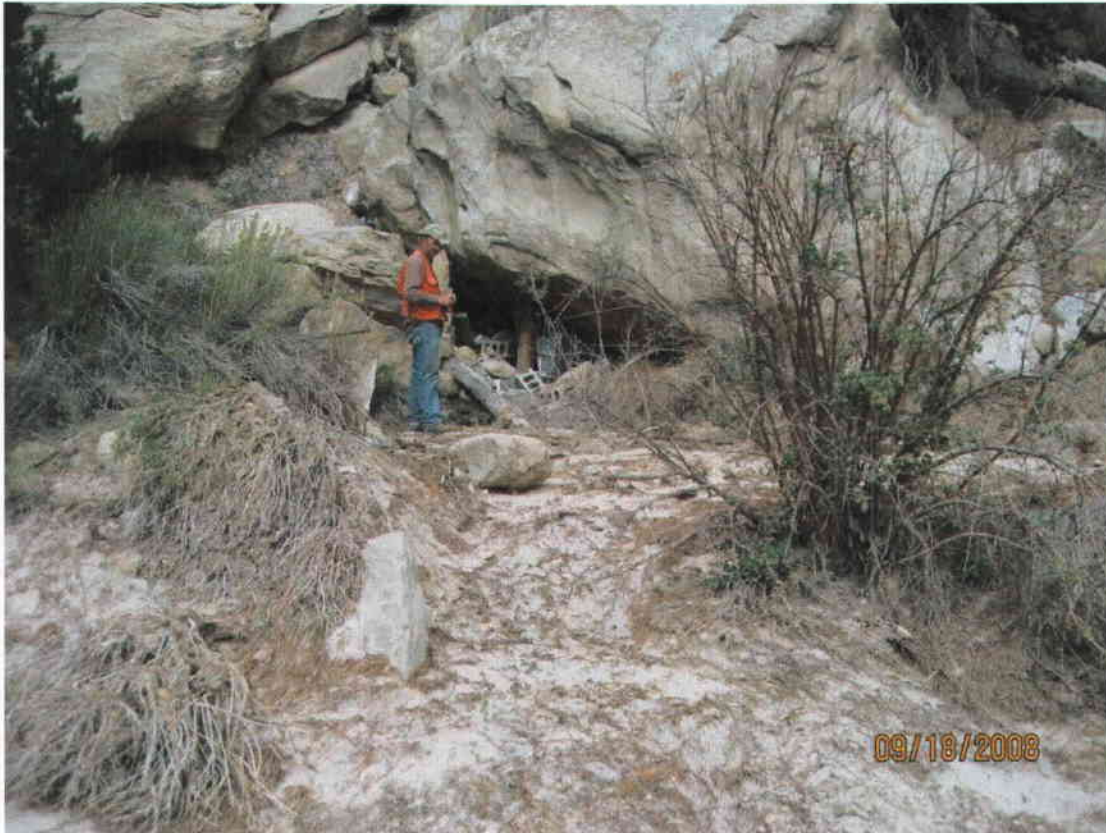
Link Canyon East Portal Study Area

Flash flood waters were at least 47 inches deep at this portal as shown by debris on vegetation adjacent to the flood path. Much of the vegetation at this site has either been destroyed or severely damaged. Most of the aerial vegetation on the dogwood bush (*Cornus stolonifera*) is dead however, there is some new sprouting from the base of the plant. There is still considerable root masses of wiregrass (*Junus sp.*) remaining of the site which may grow next spring. The Rabbitbrush (*Chrysothamnus nauseosus*) and Clematis (*Clematis liquistifolia*) above the high water line are still surviving. It is impossible to tell if any other ground species survived. There was evidence of either the willow or *Ribes* species. The stake for taking the photo point photo was destroyed and will be reestablished.

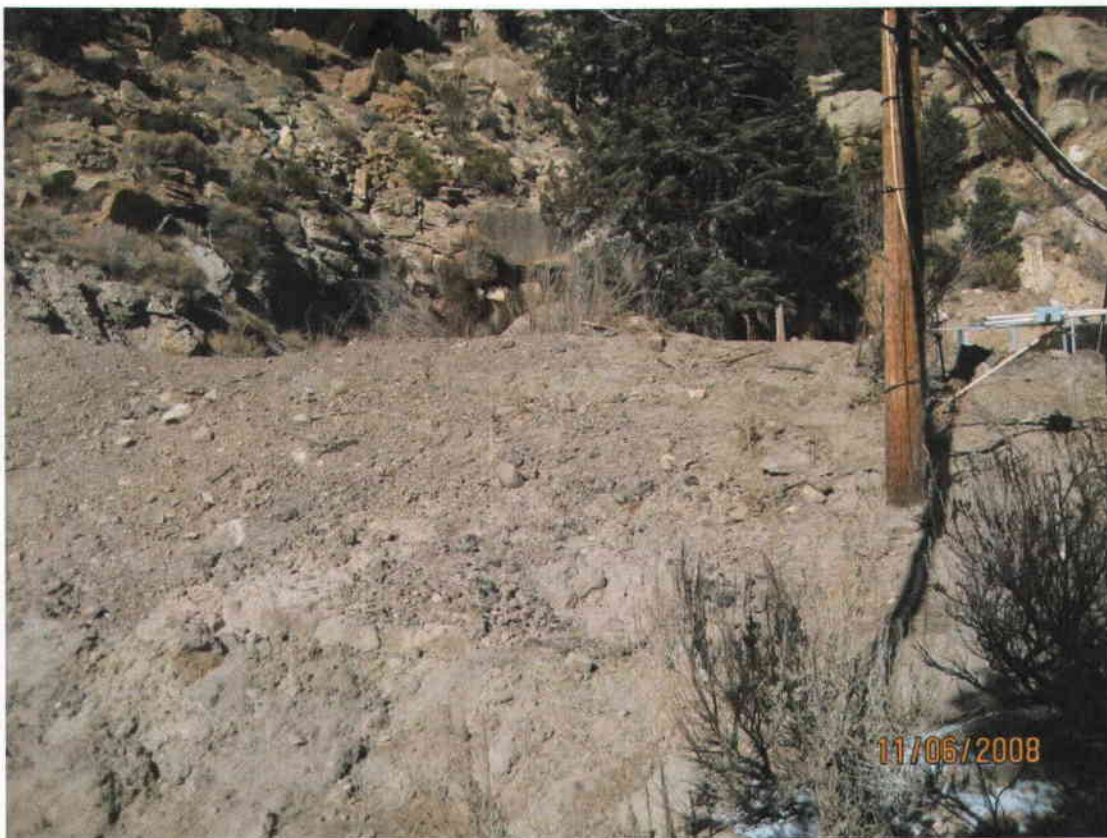
West Portal Area

There is no new growth on the Squawbush (*Rhus aramatica* var. *trilobata*) or on the willow (*Salix spp.*) plants that survived the flash flood in August this year. There are some grass seedlings starting to germinate on the area that was seeded with the interim seed mixture. The interim seed mixture consists of grass species only and includes the following species: Mountain Brome (*Bromus carinatus*), Giant Wildrye (*Elymus cinereus*), Western Wheatgrass (*Elymus smithii*), Bluebunch Wheatgrass (*Elymus*

spicatus), Slender wheatgrass (*Elymus trachycaulus*), Indian ricegrass (*Stipa hymneoides*).

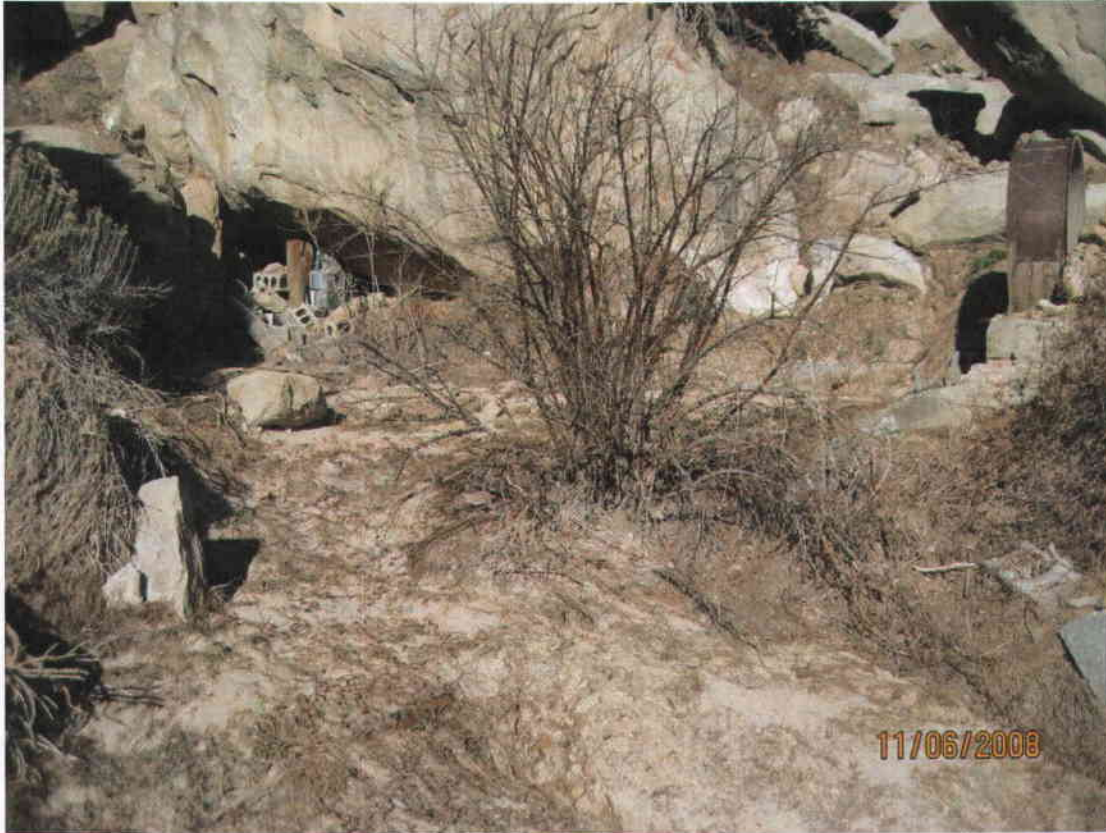
East Portal Area

This site is completely dormant. The Rabbitbrush (*Chrysothamnus nauseosus*) above the flood line has bloomed and set some seed. Some of the basal sprouts of the Dogwood (*Cornus stolonifera*) bush appear to still be living. The other species at this site are dormant.

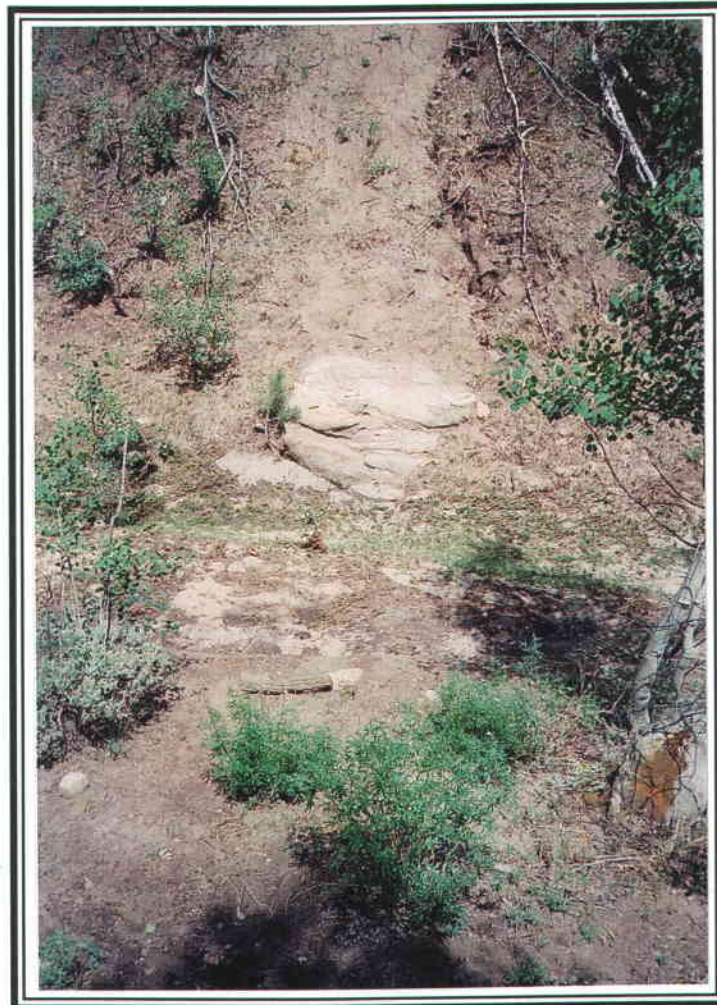
Sample Site	Other Name	Side of Stream (looking downstream)	Width (ft.)	Community Type
EFB-3		Left	4.0	<i>Agrostis stolonifera</i> / <i>Carex lanuginosa</i>
		Right	3.0	<i>Agrostis stolonifera</i> / <i>Carex lanuginosa</i>
		Channel	n/a	Dry, but vegetated

COVER BY SPECIES	PERCENT
TREES & SHRUBS	
FORBS	
<i>Artemisia dracunculus</i>	6.25
<i>Lupinus sp.</i>	6.25
GRASSES	
<i>Carex lanuginosa</i>	6.25
<i>Poa pratensis</i>	18.75
TOTAL COVER	
LIVING COVER (vascular)	
WATER	37.50
MOSS	0.00
LITTER	12.50
B/G	43.75
ROCK	6.25
TOTAL	100.00

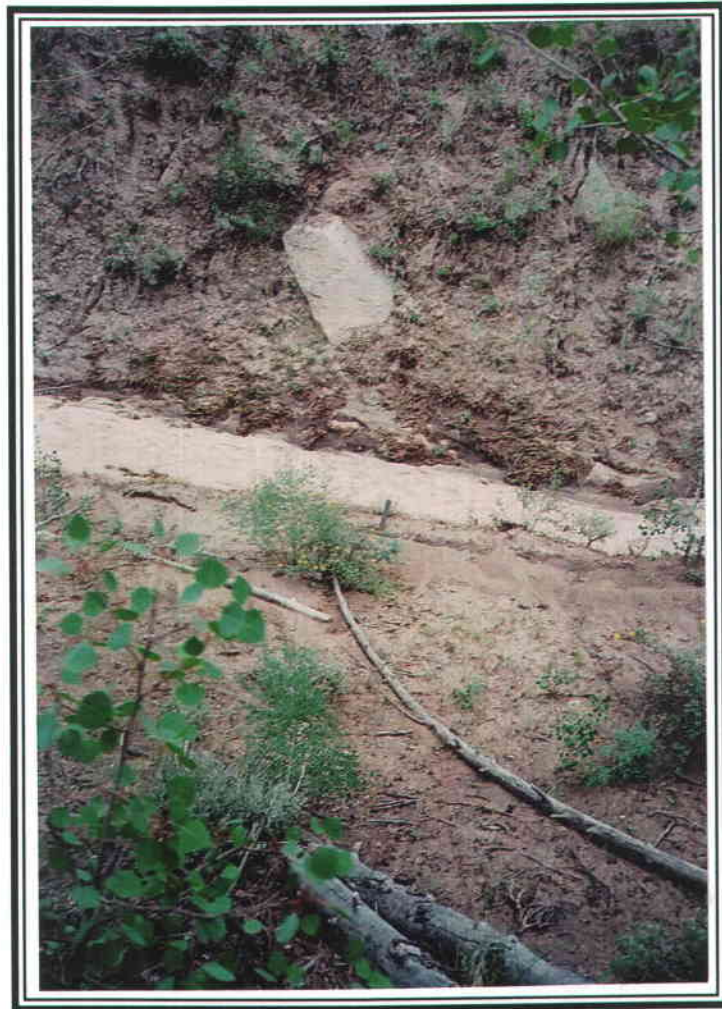
Sample Site	Other Name	Side of Stream (looking downstream)	Width (ft.)	Community Type
EFB-5		Left	2.0	<i>Agrostis stolonifera</i> / <i>Salix exigua</i>
		Right	3.0	<i>Agrostis stolonifera</i>
		Channel	3.0	Dry, sandy

COVER BY SPECIES	PERCENT
TREES & SHRUBS	
FORBS	
<i>Artemisia dracunculus</i>	6.25
<i>Lupinus argenteus</i>	12.50
GRASSES	
<i>Agrostis stolonifera</i>	12.50
TOTAL COVER	
LIVING COVER (vascular)	31.25
WATER	0.00
MOSS	0.00
LITTER	12.50
B/G	50.00
ROCK	6.25
TOTAL	100.00

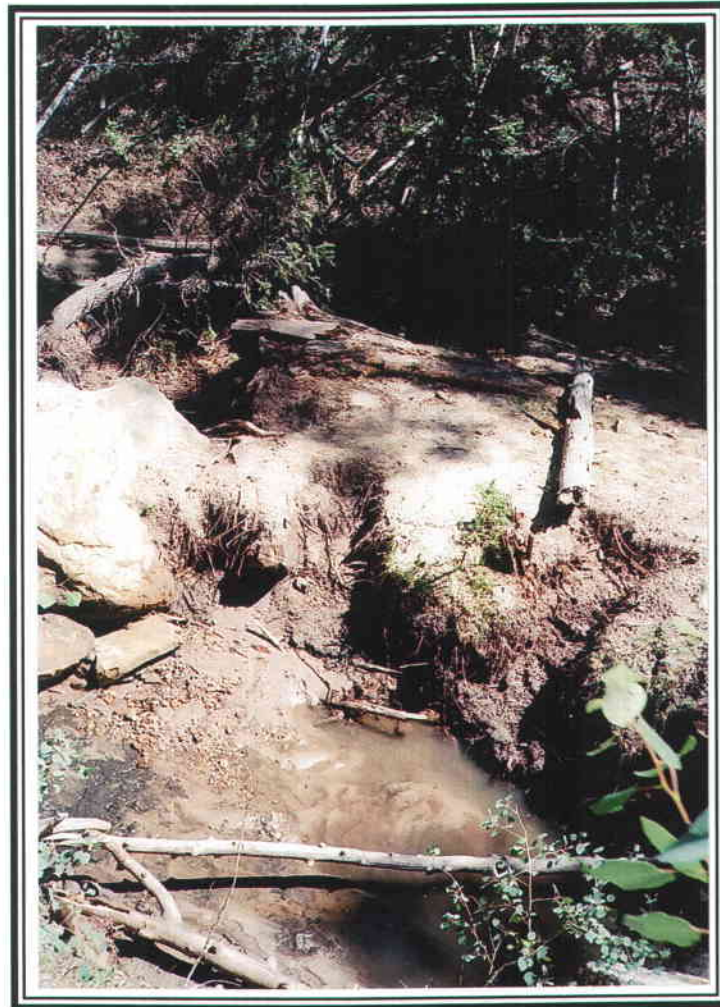
EFB-8

COVER BY SPECIES	PERCENT
TREES & SHRUBS	
<i>Picea pungens</i>	5.56
<i>Populus tremuloides</i>	5.56
FORBS	
GRASSES	
<i>Poa pratensis</i>	5.56
TOTAL COVER	
LIVING COVER (vascular)	16.67
WATER	16.67
MOSS	0.00
LITTER	22.22
B/G	38.89
ROCK	5.56
TOTAL	100.00

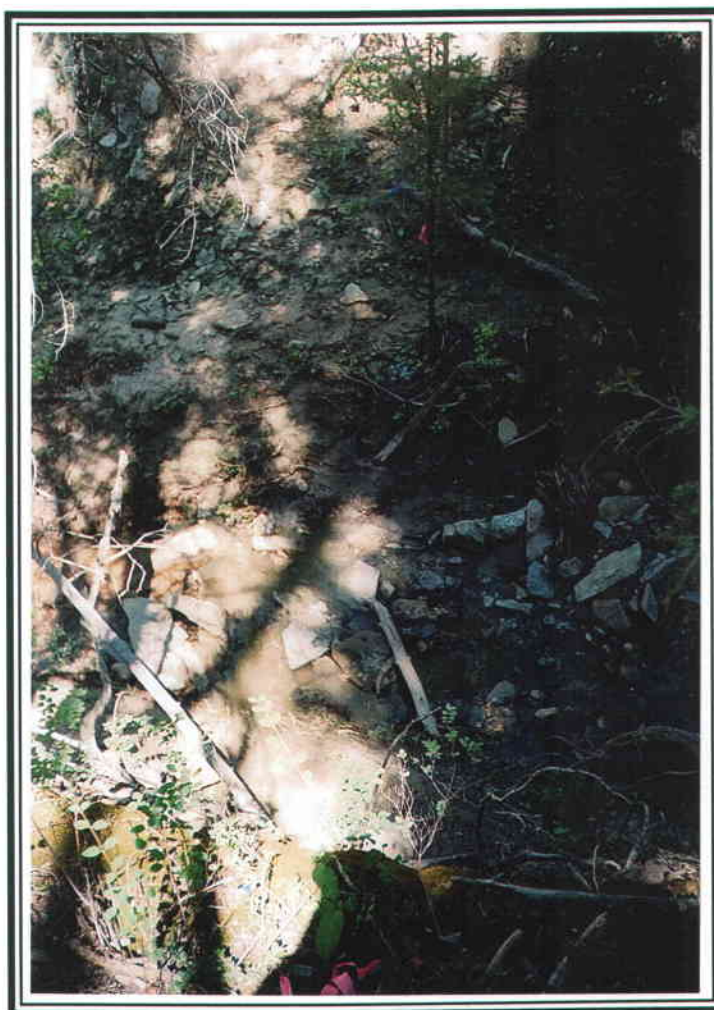
EFB-11

COVER BY SPECIES	PERCENT
TREES & SHRUBS	
FORBS	
<i>Equisetum arvense</i>	6.67
<i>Cirsium</i> sp.	6.67
<i>Geranium richardsonii</i>	6.67
GRASSES	
TOTAL COVER	
LIVING COVER (vascular)	20.00
WATER	6.67
MOSS	6.67
LITTER	26.67
B/G	20.00
ROCK	20.00
TOTAL	100.00

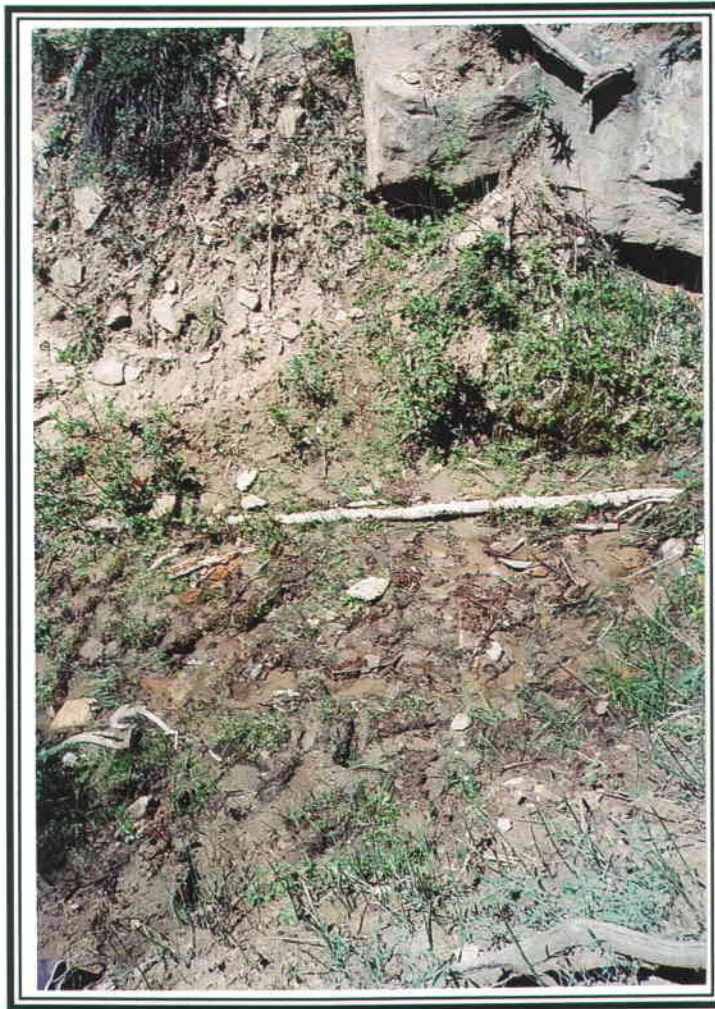
EFB-S1

Cover (ft)
UPLAND VEGETATION	
<i>Aster/Bareground</i>	15.00
<i>Bromus carinatus</i>	9.00
RIPARIAN VEGETATION	
<i>Geranium richardsonii/Equisetum arvense</i>	3.00
<i>Ranunculus cymbalaria/Equisetum arvensis</i>	8.00
TOTAL COVER (Upland Species)	24.00
TOTAL COVER (Riparian Species)	11.00
Bareground/LITTER	0.00
ROCK	0.00
WATER/MUD/DRY CHANNEL	2.00
MOSS	0.00
TOTAL COVER	37.00

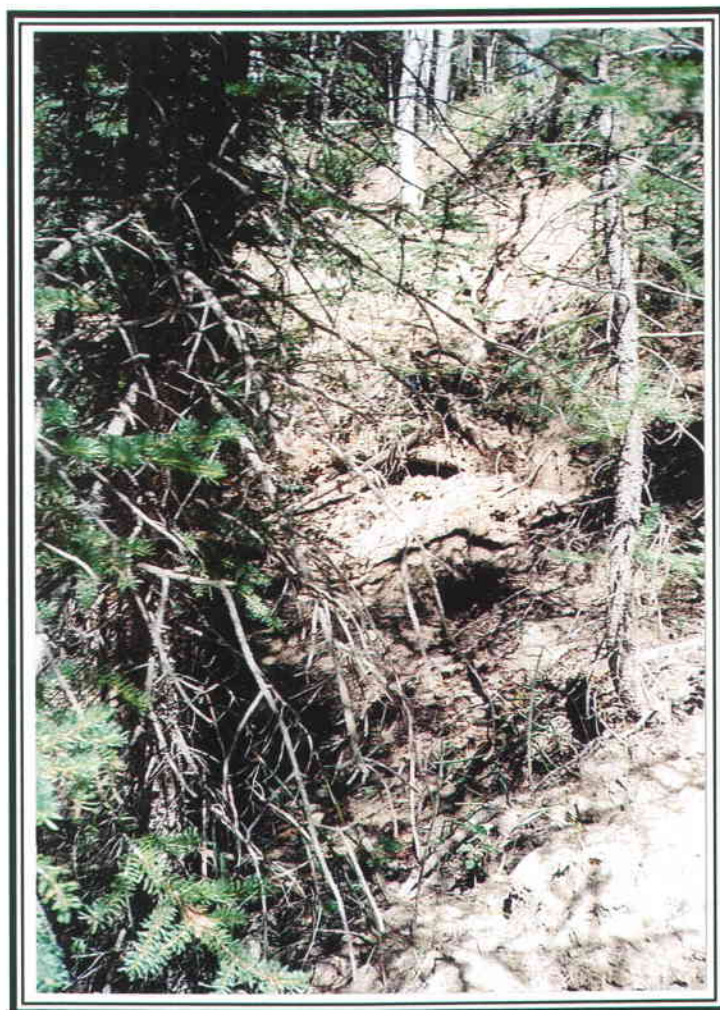
EFB-S4 (EFB-14)

<u>USDA Forest Service Protocol (1992)</u>		Cover (ft)
UPLAND VEGETATION		
<i>Populus tremuloides/Festuca ovian</i>		4.00
RIPARIAN VEGETATION		
<i>Equisetum arvensis</i>		15.00
TOTAL COVER (Upland Species)		4.00
TOTAL COVER (Riparian Species)		15.00
BAREGROUND/LITTER		0.00
ROCK		0.00
WATER/MUD/DRY CHANNEL		0.00
Moss		0.00
TOTAL COVER		19.00

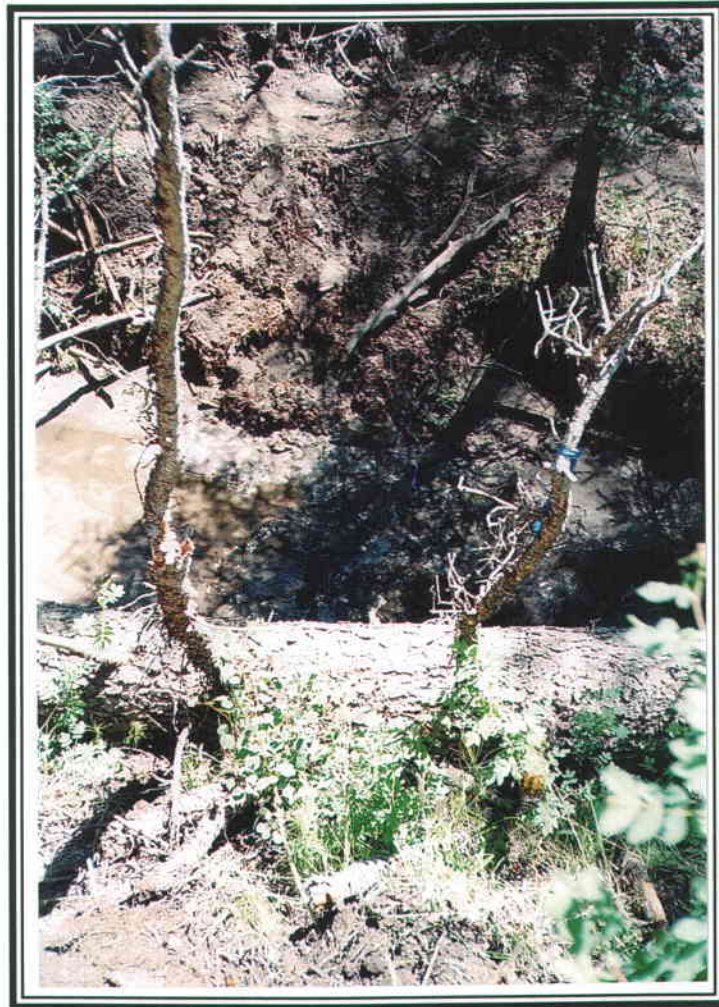
RE-11

Cover (ft)
UPLAND VEGETATION	
<i>Populus tremuloides/Rosa woodsii</i>	22.50
RIPARIAN VEGETATION	
<i>Agrostis stolonifera</i>	1.00
TOTAL COVER (Upland Species)	22.50
TOTAL COVER (Riparian Species)	1.00
BAREGROUND/LITTER	0.00
ROCK	1.50
WATER/MUD/DRY CHANNEL	4.00
MOSS	0.00
TOTAL COVER	29.00

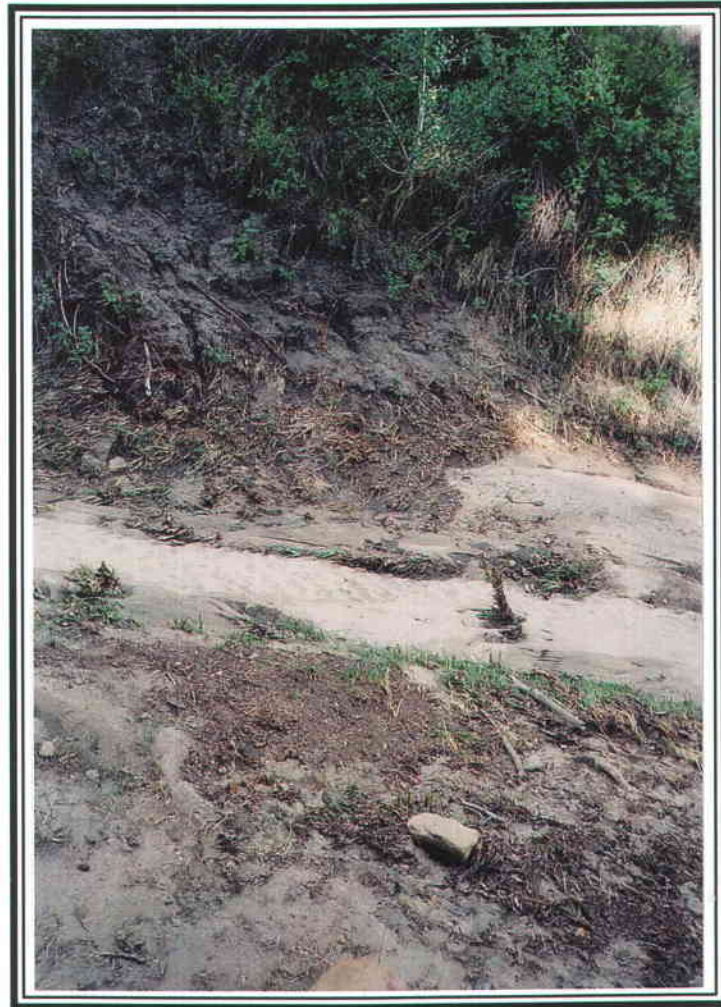
RE-12

Cover (ft)
UPLAND VEGETATION	
<i>Artemisia tridentata</i> / <i>Elymus trachycaulus</i>	13.00
<i>Populus tremuloides</i> / <i>Rosa woodsii</i>	8.00
RIPARIAN VEGETATION	
<i>Agrostis stolonifera</i>	1.50
<i>Agrostis stolonifera</i> / <i>Carex nebrascensis</i>	4.00
TOTAL COVER (Upland Species)	21.00
TOTAL COVER (Riparian Species)	5.50
BAREGROUND/LITTER	2.00
ROCK	0.00
WATER/MUD/DRY CHANNEL	1.00
MOSS	0.00
TOTAL COVER	29.50

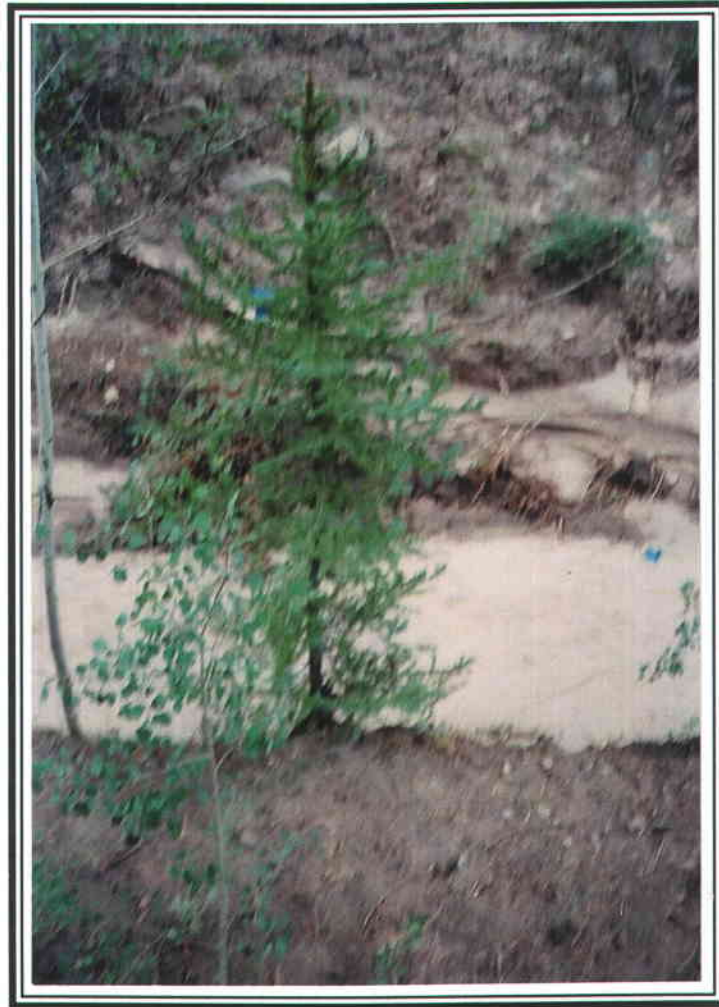
RE-13

Cover (ft)
UPLAND VEGETATION	
<i>Artemisia tridentata/Elymus trachycaulus</i>	10.50
<i>Populus tremuloides</i>	10.00
RIPARIAN VEGETATION	
<i>Agrostis stolonifera</i>	3.00
TOTAL COVER (Upland Species)	20.50
TOTAL COVER (Riparian Species)	3.00
BAREGROUND/LITTER	4.00
ROCK	0.00
WATER/MUD/DRY CHANNEL	0.00
MOSS	0.00
TOTAL COVER	27.50

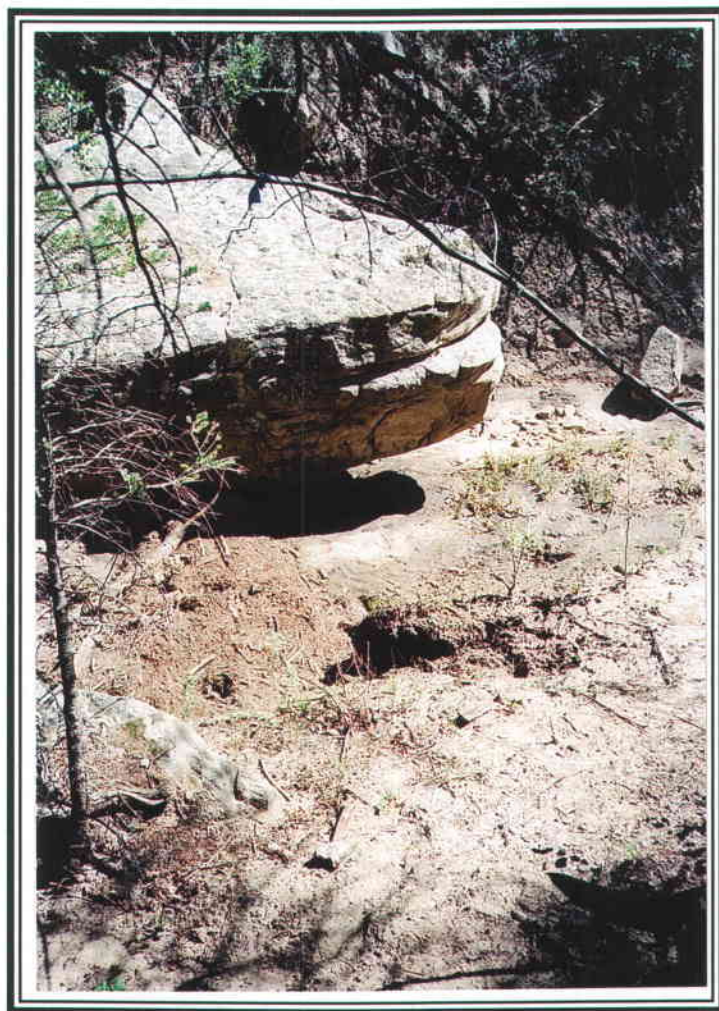
R-07

Cover (ft)
UPLAND VEGETATION	
<i>Picea pungens</i>	10.00
<i>Populus tremuloides</i>	11.00
RIPARIAN VEGETATION	
<i>Agrostis stolonifera</i>	2.00
<i>Carex lanuginosa</i>	2.00
TOTAL COVER (Upland Species)	21.00
TOTAL COVER (Riparian Species)	4.00
BAREGROUND/LITTER	6.00
ROCK	8.00
WATER/MUD/DRY CHANNEL	0.00
MOSS	0.00
TOTAL COVER	39.00

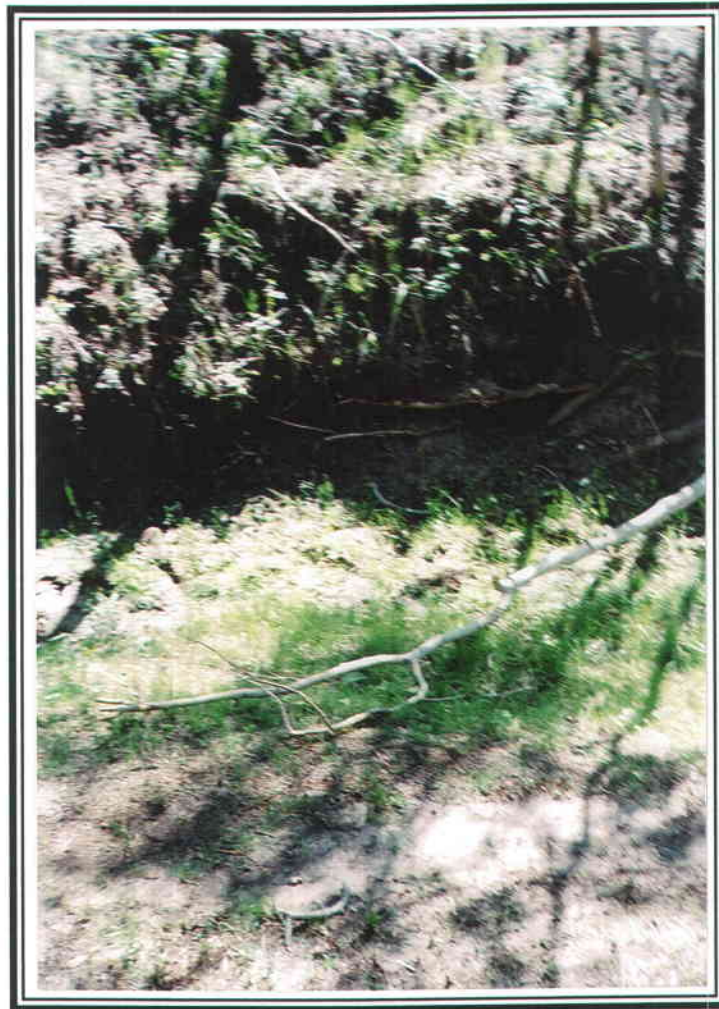
R-09

Cover (ft)
UPLAND VEGETATION	
<i>Populus tremuloides</i>	18.00
RIPARIAN VEGETATION	
<i>Carex lanuginosa</i> / <i>Agrostis stolonifera</i>	11.00
TOTAL COVER (Upland Species)	18.00
TOTAL COVER (Riparian Species)	11.00
BAREGROUND/LITTER	0.00
ROCK	0.00
WATER/MUD/DRY CHANNEL	0.00
MOSS	0.00
TOTAL COVER	29.00

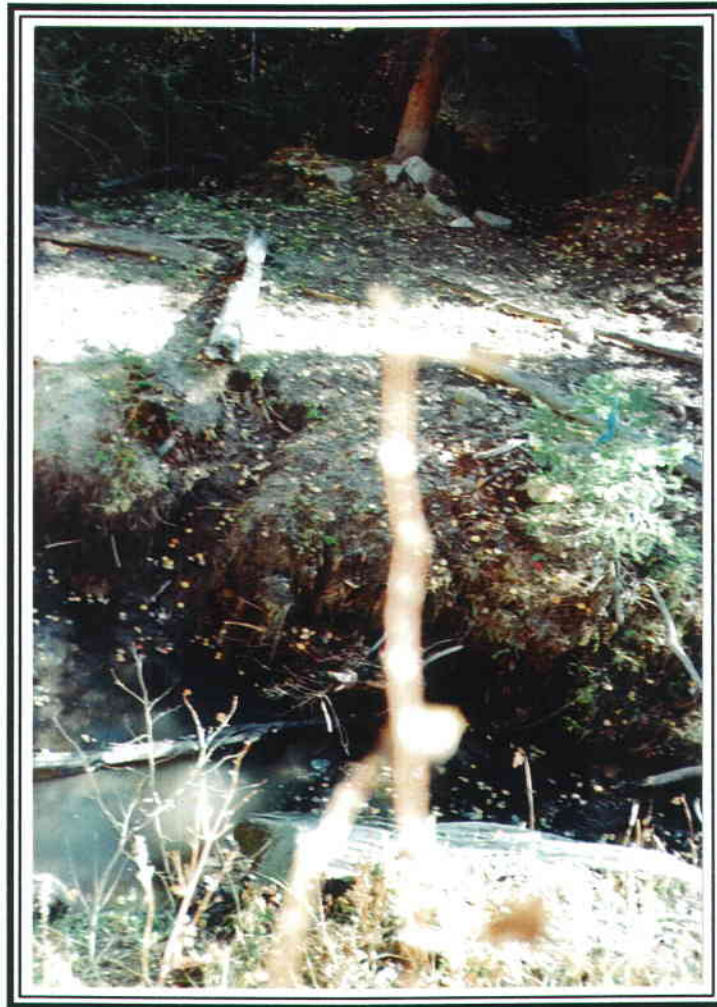
EFB-8

COVER BY SPECIES	PERCENT
TREES & SHRUBS	
<i>Picea pungens</i>	5.88
FORBS	
<i>Equisetum arvense</i>	11.76
GRASSES/GRASS-LIKES	
<i>Agrostis stolonifera</i>	5.88
<i>Poa pratensis</i>	11.76
TOTAL COVER	
LIVING COVER (vascular)	35.29
WATER	17.65
MOSS	0.00
LITTER	17.65
B/G	23.53
ROCK	5.88
TOTAL	100.00

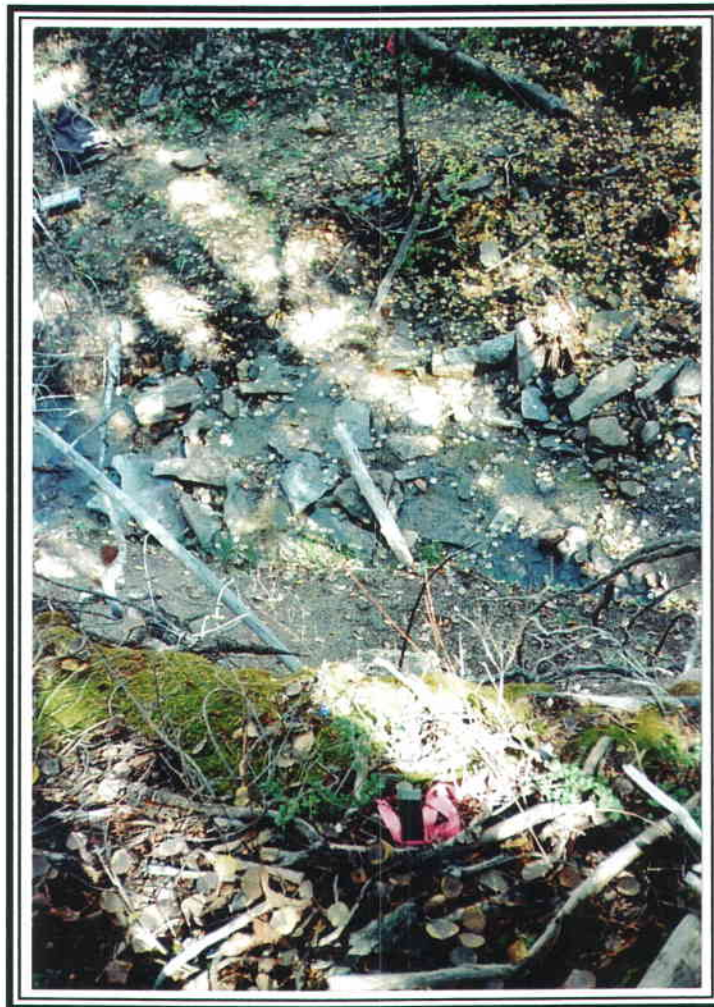
EFB-11

COVER BY SPECIES	PERCENT
TREES & SHRUBS	
FORBS	
<i>Equisetum arvense</i>	6.67
<i>Geranium richardsonii</i>	6.67
GRASSES/GRASS-LIKES	
TOTAL COVER	
LIVING COVER (vascular)	13.33
WATER	13.33
MOSS	6.67
LITTER	13.33
B/G	40.00
ROCK	13.33
TOTAL	100.00

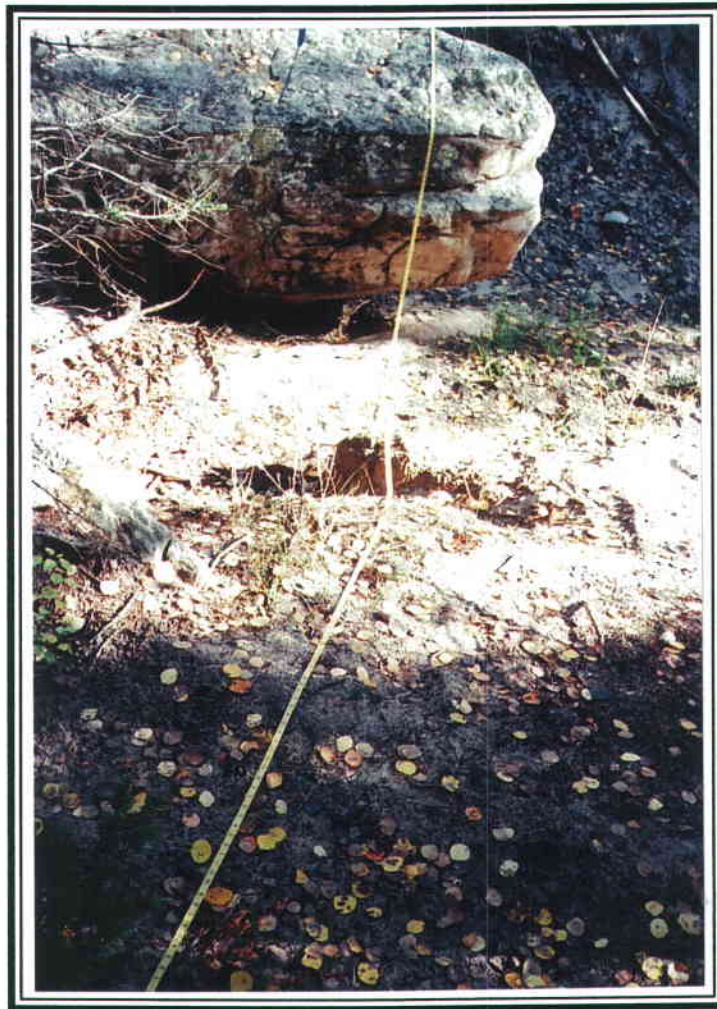
R-07

Cover (ft)
UPLAND VEGETATION	
<i>Picea pungens</i>	10.00
<i>Populus tremuloides</i>	10.50
RIPARIAN VEGETATION	
<u>Dominant Woody Species</u>	
<u>Dominant Herbaceous Species</u>	
<i>Carex lanuginosa</i> / <i>Agrostis stolonifera</i>	3.00
TOTAL COVER (Upland Species)	20.50
TOTAL COVER (Riparian Species)	3.00
BAREGROUND/LITTER	12.00
ROCK	2.00
WATER/MUD/DRY CHANNEL	0.00
MOSS	0.00
TOTAL COVER	37.50

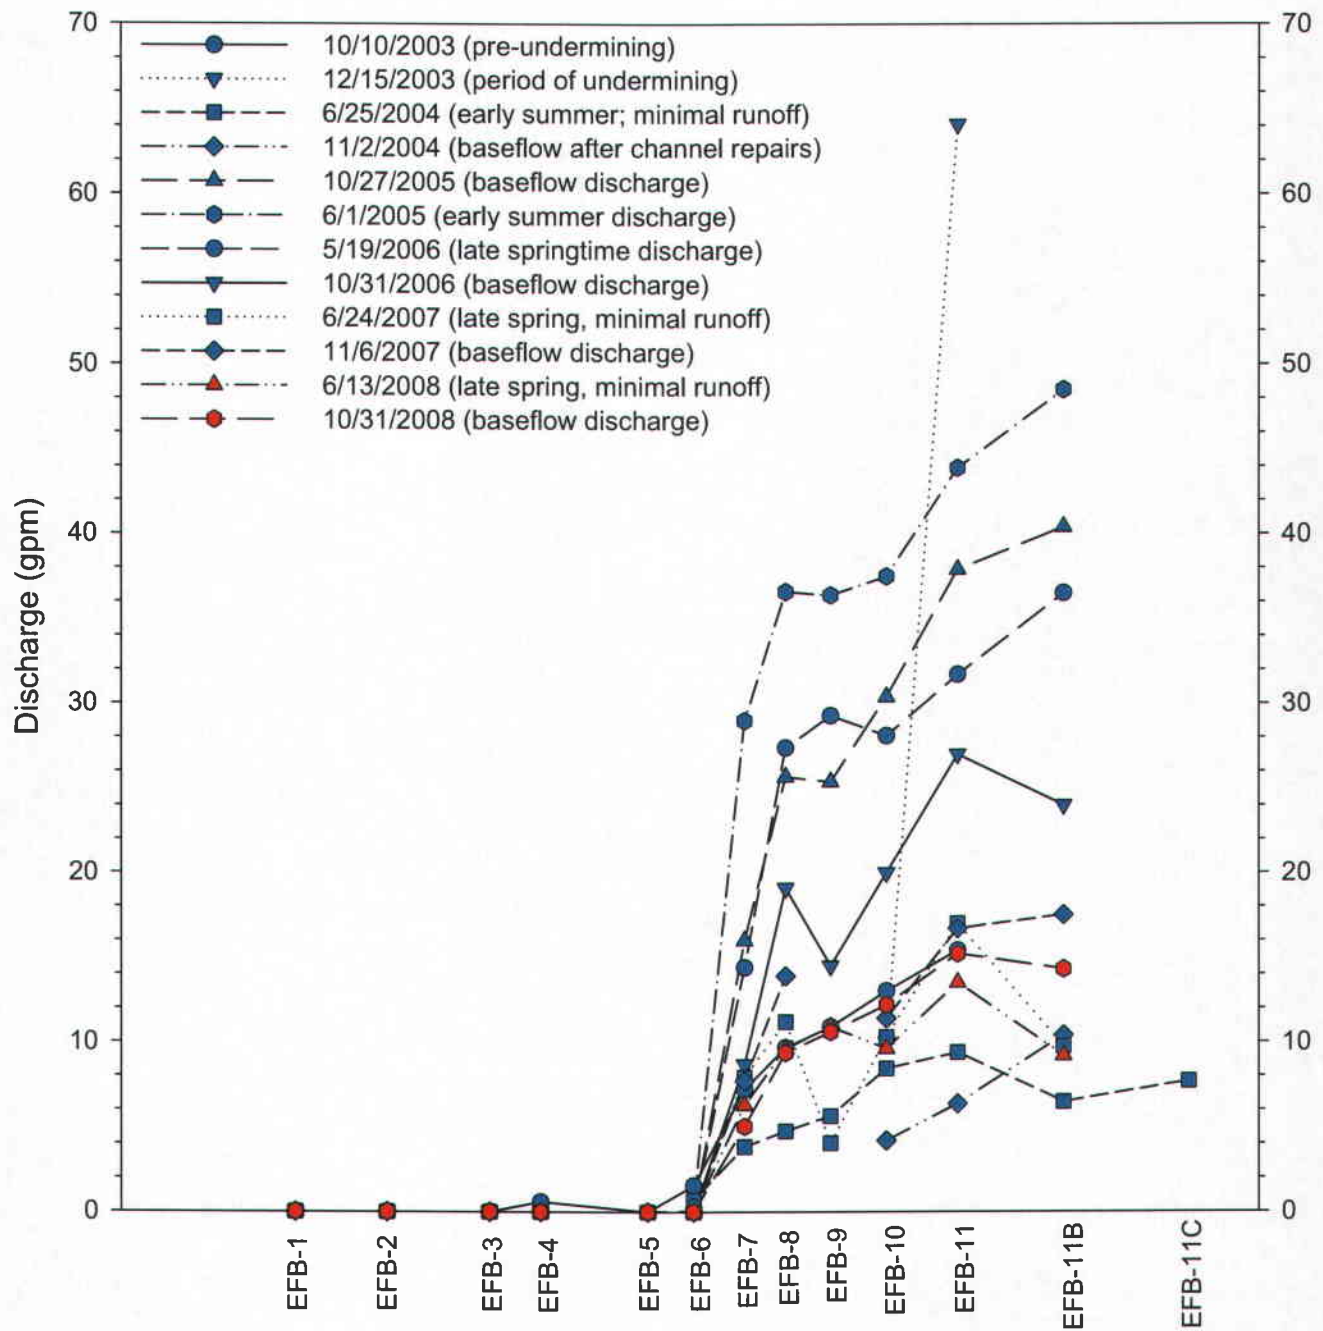
Figure 8 Plots of discharge from East Fork of Box Canyon Creek monitoring sites.

Note: 2008 data shown in red.
Discharge data from EFB-11A not shown on graph.

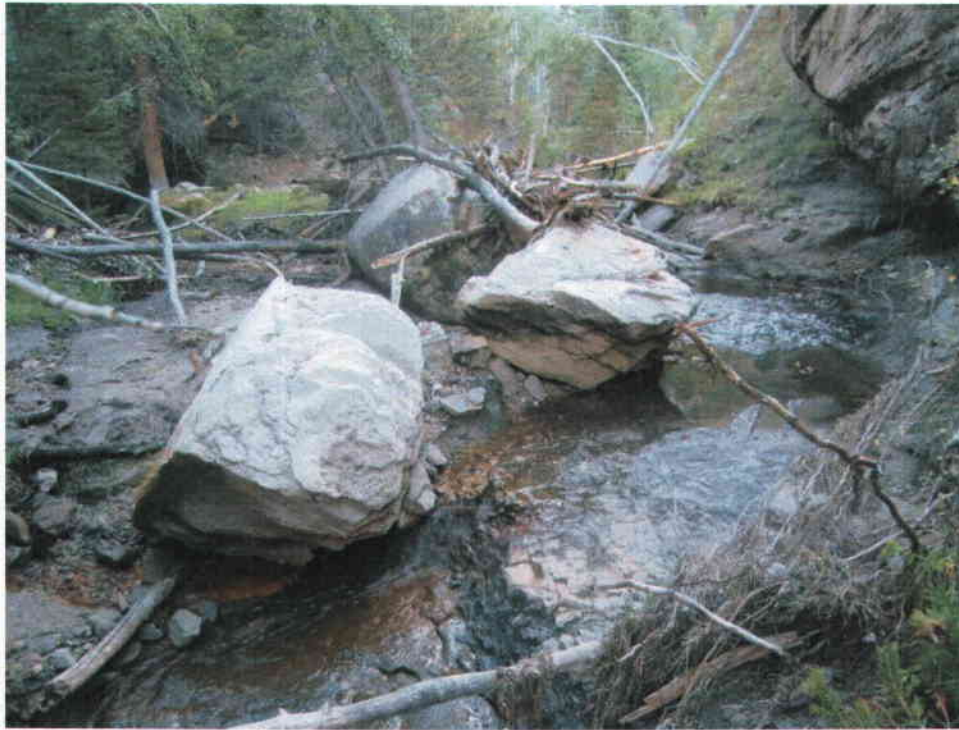
Figure 9 Waterfall in the East Fork of Box Canyon near EFB-11.

The conclusion that the water flowing beneath the dry stream reaches was moving through the shallow subsurface is also evidenced by observations at ledges and waterfalls in the East Fork drainage. At many such locations, water was observed discharging from the waterfall or ledge only a few inches to a few feet below the top of the ledge (Figure 9).
